**Flood Control Project Maintenance  
Levee Inspections**  
**LMA District Cover Sheet**  
**Spring 2019 Levee Inspection Results**

**Sacramento Maintenance Yard Cache Creek**

**Spring 2019 Levee Inspection Results**

Waterway			Bank	Unit Miles
Unit No. 01 North Levee			Left	11.69
	Spring (March - May)	Summer (June - August)	(September - November) Fall	Winter (December - February)
Unit Maintenance Rating (Fall Only)				
Date of Inspection	4/23/2019 - 4/23/2019			
DWR Inspector	Zach Jojola			
Accompanied By

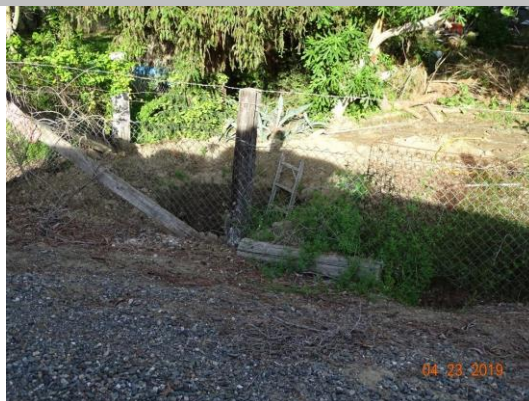
Photo 1 of 1 : SP\_2019\_ST0001\_259\_35\_20190424\_00071.jpg

LM Start	1.98	Rating **	U	Issue No.	35
LM End	1.98	Issue Type +	En	Location *	LS
Category	Earthen Levee			GPS Latitude/Longitude	
				Start	End
Item	Encroachments			38.731208 °	38.731208 °
				-121.806220 °	-121.806220 °
DWR ID	DWR_ST0001_01_s_2019_35				
Comment Code					
DT : Ditch					
Inspector Comment					
The landowner has dug a 5' diameter hole within 10' of the landside toe and it appears to cut into the levee prism.

View of the hole within the landside easement. Spring 2019.

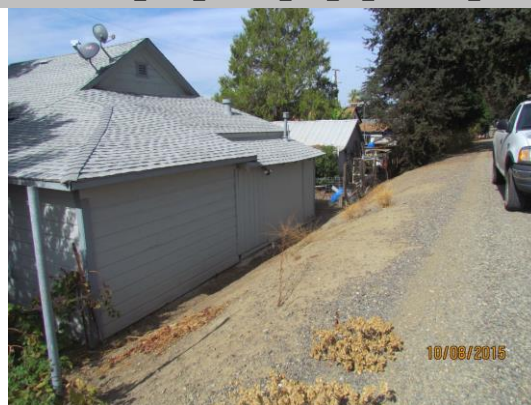
Photo 1 of 1 : SP\_2019\_ST0001\_259\_10\_20190304\_00009.jpg

LM Start	2.05	Rating **	M	Issue No.	10
LM End	2.05	Issue Type +	En	Location *	LS
Category	Earthen Levee			GPS Latitude/Longitude	
				Start	End
Item	Encroachments			38.732162 °	38.732162 °
				-121.805895 °	-121.805895 °
DWR ID	DWR_ST0001_01_s_2018_10				
Comment Code					
BU : Building					
Inspector Comment

View of the house on the landward side of the levee looking downstream. Fall 2015.

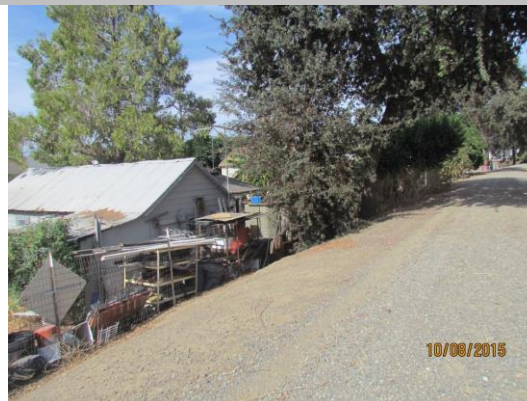
Photo 1 of 1 : SP\_2019\_ST0001\_259\_11\_20190304\_00010.jpg

LM Start	2.06	Rating **	M	Issue No.	11
LM End	2.06	Issue Type +	En	Location *	LS
Category	Earthen Levee			GPS Latitude/Longitude	
				Start	End
Item	Encroachments			38.732268 °	38.732268 °
				-121.805832 °	-121.805832 °
DWR ID	DWR_ST0001_01_s_2012_11				
Comment Code					
BU : Building					
Inspector Comment

View of the building on the landward side of the levee looking downstream. Fall 2015.

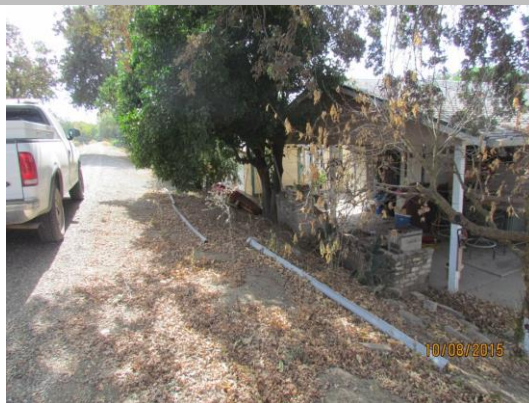
Photo 1 of 1 : SP\_2019\_ST0001\_259\_13\_20190304\_00012.jpg

LM Start	2.08	Rating **	M	Issue No.	13
LM End	2.08	Issue Type +	En	Location *	LS
Category	Earthen Levee			GPS Latitude/Longitude	
				Start	End
Item	Encroachments			38.732523 °	38.732523 °
				-121.805690 °	-121.805690 °
DWR ID	DWR_ST0001_01_s_2012_13				
Comment Code					
BU : Building					
Inspector Comment

View of the building on the landward side of the levee looking upstream. Fall 2015.

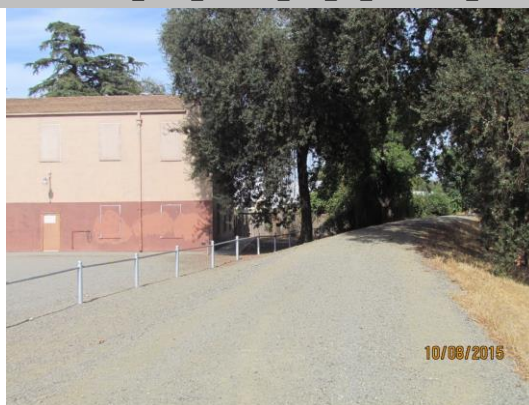
Photo 1 of 1 : SP\_2019\_ST0001\_259\_12\_20190304\_00011.jpg

LM Start	2.12	Rating **	M	Issue No.	12
LM End	2.12	Issue Type +	En	Location *	LS
Category	Earthen Levee			GPS Latitude/Longitude	
				Start	End
Item	Encroachments			38.733000 °	38.733000 °
				-121.805409 °	-121.805409 °
DWR ID	DWR_ST0001_01_s_2012_12				
Comment Code					
BU : Building					
Inspector Comment

View of the building on the landward side of the levee looking downstream. Fall 2015.

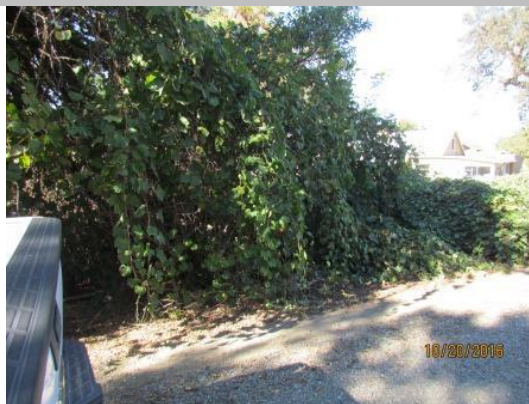
Photo 1 of 2 : SP\_2019\_ST0001\_259\_14\_20190304\_00013.jpg

LM Start	2.12	Rating **	M	Issue No.	14
LM End	2.14	Issue Type +	En	Location *	LS
Category	Earthen Levee			GPS Latitude/Longitude	
				Start	End
Item	Vegetation			38.733103 °	38.733233 °
				-121.805330 °	-121.805180 °
DWR ID	DWR_ST0001_01_s_2012_14				
Comment Code					
V6 : Landscaping					
Inspector Comment

Another view of the shrubs. Fall 2016.

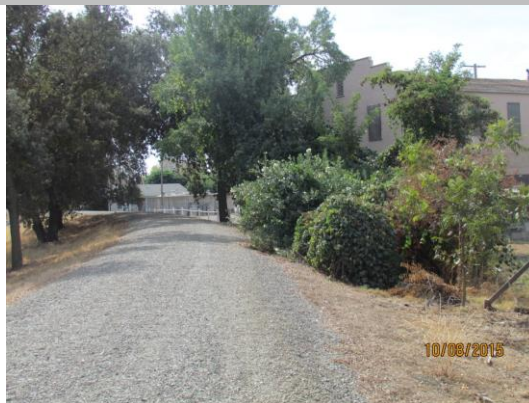
Photo 2 of 2 : SP\_2019\_ST0001\_259\_14\_20190304\_00014.jpg

LM Start	2.12	Rating **	M	Issue No.	14 (cont)	
LM End	2.14	Issue Type +	En	Location *	LS	
Category	Earthen Levee			GPS Latitude/Longitude		
				Start		End
Item	Vegetation			38.733103 °		38.733233 °
				-121.805330 °		-121.805180 °
DWR ID	DWR_ST0001_01_s_2012_14					
Comment Code						
V6 : Landscaping						
Inspector Comment

View of the shrubs on the landward side of the levee looking upstream.  
Fall 2015.

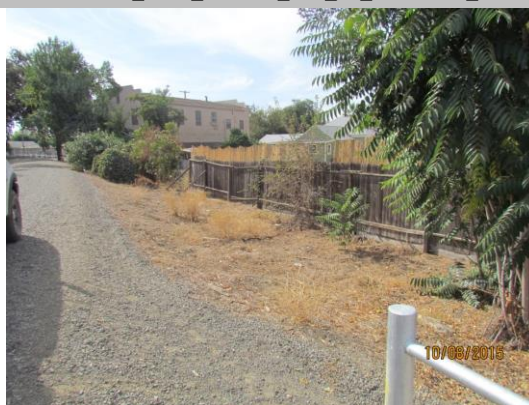
Photo 1 of 1 : SP\_2019\_ST0001\_259\_15\_20190304\_00015.jpg

LM Start	2.13	Rating **	U	Issue No.	15
LM End	2.15	Issue Type +	En	Location *	LS
Category	Earthen Levee			GPS Latitude/Longitude	
				Start	End
Item	Encroachments			38.733215 °	38.733350 °
				-121.805262 °	-121.805082 °
DWR ID	DWR_ST0001_01_s_2012_15				
Comment Code					
FE : Fence					
Inspector Comment

View of the fence on the landward side of the levee looking upstream.  
Fall 2015.

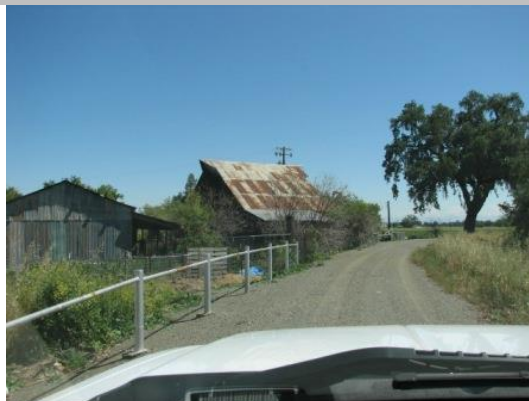
Photo 1 of 2 : SP\_2019\_ST0001\_259\_16\_20190304\_00016.jpg

LM Start	2.17	Rating **	M	Issue No.	16
LM End	2.17	Issue Type +	En	Location *	LS
Category	Earthen Levee			GPS Latitude/Longitude	
				Start	End
Item	Encroachments			38.733580 °	38.733580 °
				-121.804650 °	-121.804650 °
DWR ID	DWR_ST0001_01_s_2012_16				
Comment Code					
BU : Building					
Inspector Comment

Horse barn and corral are within the easement of the levee.

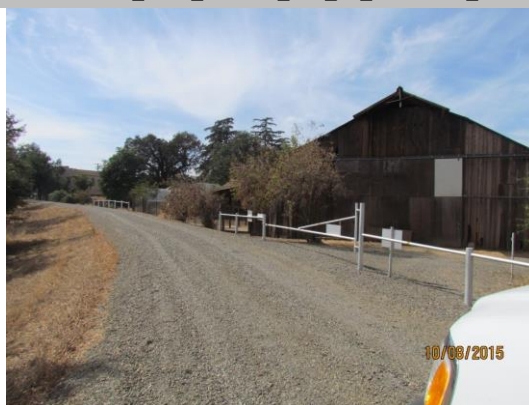
Photo 2 of 2 : SP\_2019\_ST0001\_259\_16\_20190304\_00017.jpg

LM Start	<b>2.17</b>	Rating **	M	Issue No.	<b>16 (cont)</b>
LM End	<b>2.17</b>	Issue Type +	En	Location *	LS

View of the horse barn on the landward side of the levee looking upstream. Fall 2015.

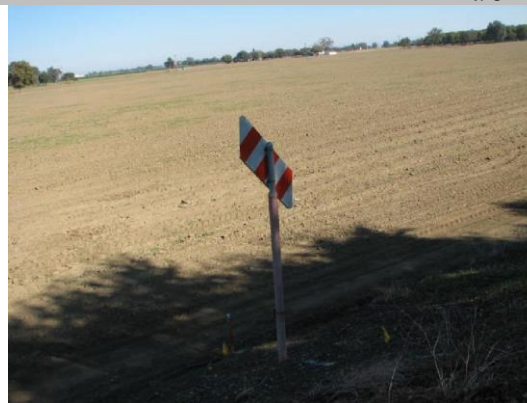
Photo 2 of 3 : UCIP\_SP\_2019\_49099\_60163.jpg

LM Start	2.26	Rating **	M	Issue No.	84 (cont)
LM End	2.26	Issue Type +	En	Location *	
Category	Supplemental			GPS Latitude/Longitude	
				Start	End
Item	DWR UCIP Field Study			38.733675 °	38.733675 °
				-121.803009 °	-121.803009 °
DWR ID	16268				
Comment Code					
Inspector Comment					
FS_ID:49099 DS_ID:16268 EP_NO: 2415 Repair Type: Non-Urgent Crossing Status: Indicator Found UCIP Comments: May need to install gasoline marker on WS slope. FIELD_STRUCT_DESC: 20-inch wrapped steel natural gas pipeline through the levee, 4 feet below the crown. Two cutoff walls. Gas line indicator found on the landside (LS) of the levee. (20-inch wrapped steel natural gas pipeline authorized under Permit No. 2415, 1956 - Pacific Gas and Electric Company [PG&E]). [Additional Reference(s): DWR Levee Log, 1993. USACE Sacramento O&M Manual 126, November 1961, (HLM 2.24)]. FS Date: 6/16/2016 7:00:04 AM

Landside view: gasoline indicator

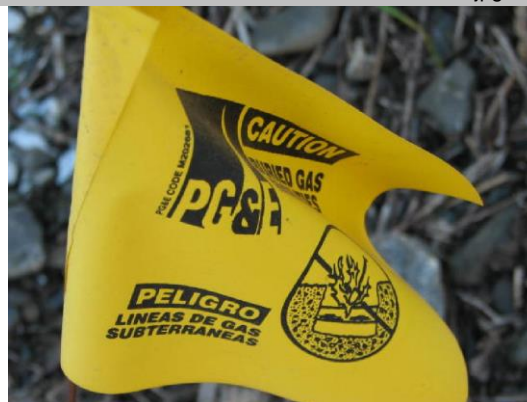
Photo 3 of 3 : UCIP\_SP\_2019\_49099\_60165.jpg

Landside view: gasoline indicator/flag

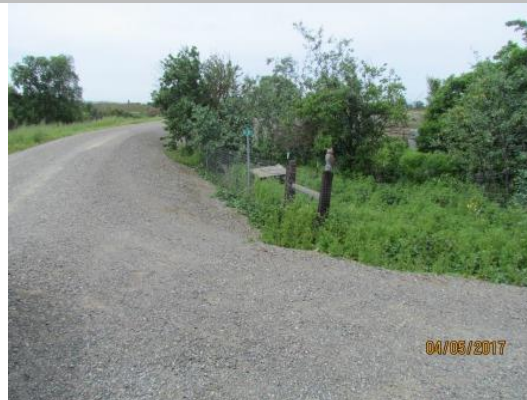
Photo 1 of 1 : SP\_2019\_ST0001\_259\_78\_20190304\_00050.jpg

LM Start	2.54	Rating **	M	Issue No.	78
LM End	2.61	Issue Type +	En	Location *	LS
Category	Earthen Levee			GPS Latitude/Longitude	
				Start	End
Item	Encroachments			38.733285 °	38.732782 °
				-121.798029 °	-121.797167 °
DWR ID	DWR_ST0001_01_s_2017_78				
Comment Code					
FE : Fence					
Inspector Comment					
There is a wire fence at the landside levee toe.

Chain fence at landside levee toe. Spring 2017.

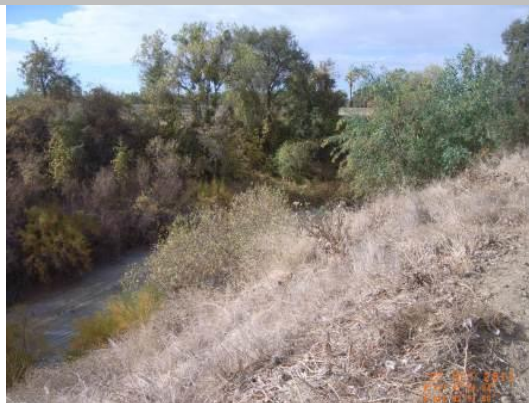
Photo 3 of 3 : SP\_2019\_ST0001\_259\_30\_20190304\_00025.jpg

LM Start	2.57	Rating **	A/W	Issue No.	30 (cont)
LM End	2.61	Issue Type +	Ma	Location *	WS
Category	Supplemental			GPS Latitude/Longitude	
				Start	End
Item	2017 USACE Erosion Survey, DRAFT			38.732836 °	38.732685 °
				-121.797893 °	-121.797154 °
DWR ID	DWR_ST0001_01_f_ 2018_30				
Comment Code					
Inspector Comment					
2017 Site ID: CHC 2.4 L Status: Critical 2017 Field Notes: No observed change. Site History: Site identified as CRITICAL in 2002. 2006 - Currently constructing a setback levee. New failures present and extensive. Downstream end of the setback levee did not extend far enough. Upstream end was repaired. 2007 - DWR repaired with a setback levee, but the levee did not go far enough downstream. 2012 - New cracks observed. 2013 - Fresh erosion on upper bank.  DWR Inspector Comment: No observed changes in erosion. Spring 2019.

USACE 2013 Photo #1

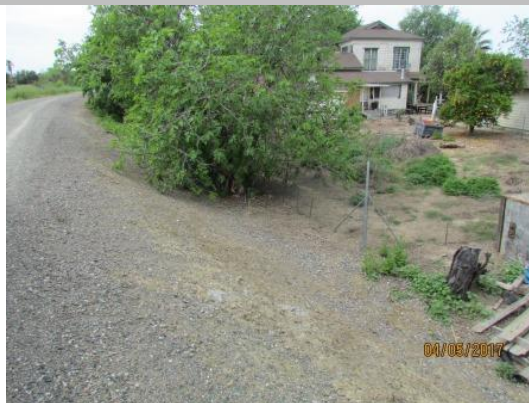
Photo 1 of 1 : SP\_2019\_ST0001\_259\_77\_20190304\_00049.jpg

LM Start	2.62	Rating **	M	Issue No.	77
LM End	2.64	Issue Type +	En	Location *	LS
Category	Earthen Levee			GPS Latitude/Longitude	
				Start	End
Item	Encroachments			38.732795 °	38.732897 °
				-121.797050 °	-121.796547 °
DWR ID	DWR_ST0001_01_s_ 2017_77				
Comment Code					
FE : Fence					
Inspector Comment					
There is a wire fence at the landside toe.

Chain fence at landside levee toe. Spring 2017.

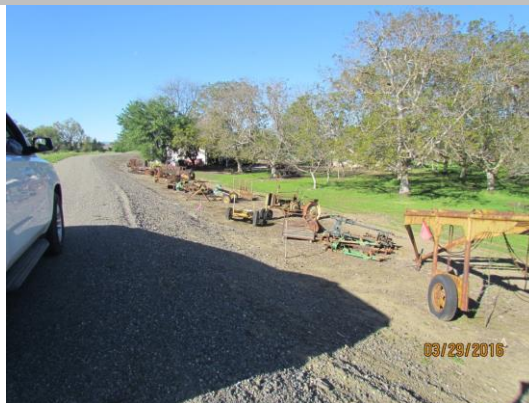
Photo 1 of 1 : SP\_2019\_ST0001\_259\_71\_20190304\_00047.jpg

LM Start	2.67	Rating **	M	Issue No.	71
LM End	2.74	Issue Type +	En	Location *	LS
Category	Earthen Levee			GPS Latitude/Longitude	
				Start	End
Item	Encroachments			38.733075 °	38.733594 °
				-121.796039 °	-121.795131 °
DWR ID	DWR_ST0001_01_s_2016_71				
Comment Code					
EQ : Equipment					
Inspector Comment

View of the equipment on the landward side of the levee looking upstream. Spring 2016.

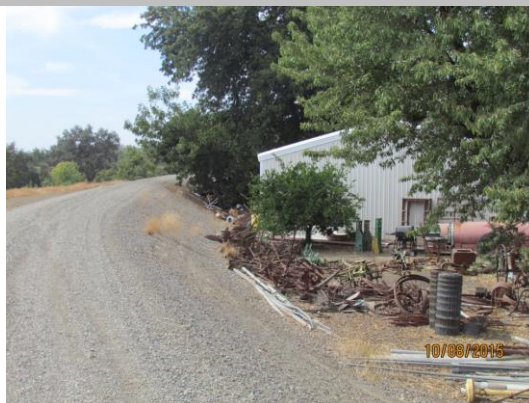
Photo 2 of 2 : SP\_2019\_ST0001\_259\_20\_20190304\_00019.jpg

LM Start	<b>2.69</b>	Rating **	M	Issue No.	<b>20 (cont)</b>
LM End	<b>2.69</b>	Issue Type +	En	Location *	LS

View of the building on the landward side of the levee looking upstream. Fall 2015.

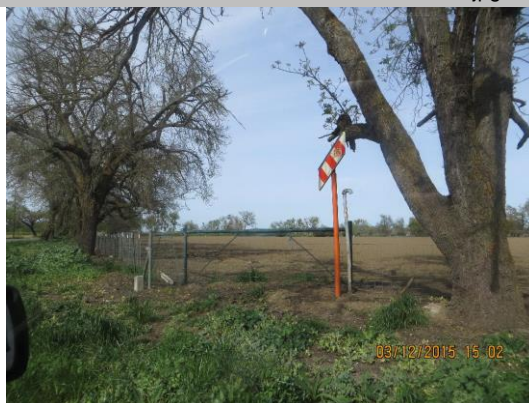
Photo 2 of 2 : UCIP\_SP\_2019\_49112\_73503.jpg

Gasline marker at Best Ranch Road, 1500-feet south of levee crossing.

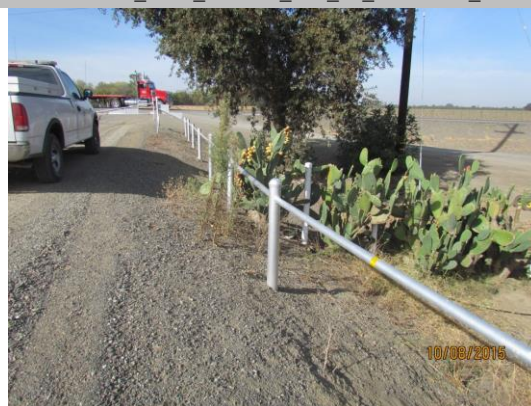
Photo 1 of 1 : SP\_2019\_ST0001\_259\_57\_20190304\_00040.jpg

LM Start	7.25	Rating **	M	Issue No.	57
LM End	7.25	Issue Type +	En	Location *	LS
Category	Earthen Levee			GPS Latitude/Longitude	
				Start	End
Item	Vegetation			38.727705 °	38.727705 °
				-121.729462 °	-121.729462 °
DWR ID	DWR_ST0001_01_f_2015_57				
Comment Code					
V6 : Landscaping					
Inspector Comment					
There is cactus on the landside slope.

View of the cactus on the landward side of the levee looking upstream.  
Fall 2015.

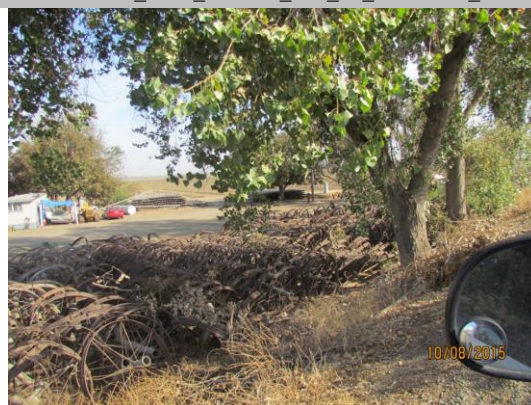
Photo 2 of 2 : SP\_2019\_ST0001\_259\_40\_20190304\_00032.jpg

LM Start	<b>7.30</b>	Rating **	M	Issue No.	<b>40 (cont)</b>
LM End	<b>7.34</b>	Issue Type +	En	Location *	LS

View of the equipment at the levee toe on the landward side looking downstream. Fall 2015.

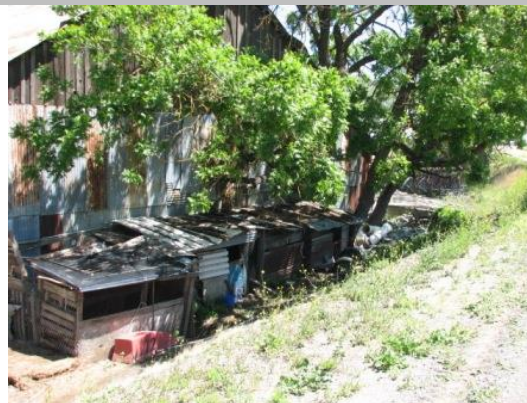
Photo 1 of 1 : SP\_2019\_ST0001\_259\_39\_20190304\_00030.jpg

LM Start	7.30	Rating **	M	Issue No.	39
LM End	7.30	Issue Type +	En	Location *	LS
Category	Earthen Levee			GPS Latitude/Longitude	
				Start	End
Item	Encroachments			38.727870 °	38.727870 °
				-121.728527 °	-121.728527 °
DWR ID	DWR_ST0001_01_s_2012_39				
Comment Code					
BU : Building					
Inspector Comment					
The barn and livestock pens are within the easement of the levee.

View of barn and livestock pens.

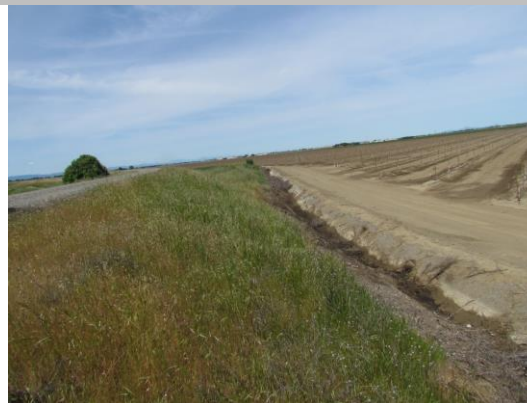
Photo 1 of 2 : SP\_2019\_ST0001\_259\_26\_20190304\_00020.jpg

LM Start	7.36	Rating **	M	Issue No.	26
LM End	7.78	Issue Type +	En	Location *	LS
Category	Earthen Levee			GPS Latitude/Longitude	
				Start	End
Item	Encroachments			38.728188 °	38.728194 °
				-121.727442 °	-121.720255 °
DWR ID	DWR_ST0001_01_s_2015_26				
Comment Code					
DT : Ditch					
Inspector Comment					
A ditch is located at the levee toe.

View of ditch on the landward side of the levee looking upstream. Spring 2015.

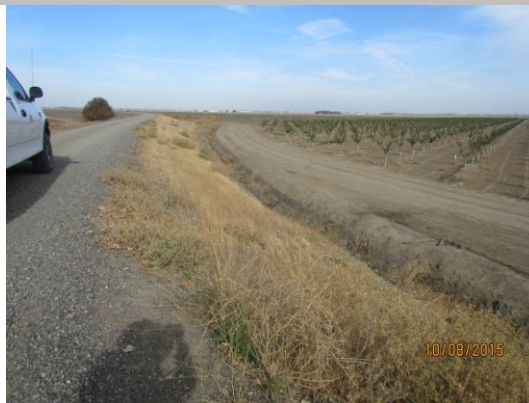
Photo 2 of 2 : SP\_2019\_ST0001\_259\_26\_20190304\_00021.jpg

LM Start	7.36	Rating **	M	Issue No.	26 (cont)	
LM End	7.78	Issue Type +	En	Location *	LS	
Category	Earthen Levee			GPS Latitude/Longitude		
				Start		End
Item	Encroachments			38.728188 °		38.728194 °
				-121.727442 °		-121.720255 °
DWR ID	DWR_ST0001_01_s_2015_26					
Comment Code						
DT : Ditch						
Inspector Comment						
A ditch is located at the levee toe.

View of the ditch on the landward side of the levee looking upstream.  
Fall 2015.

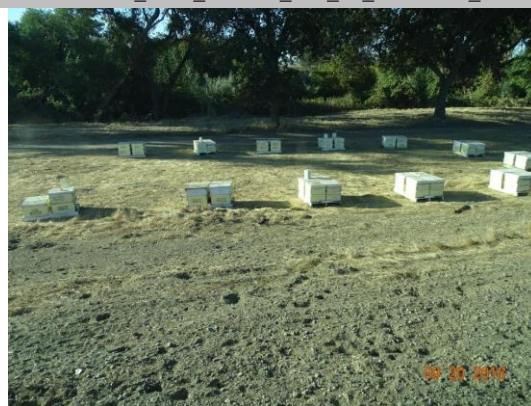
Photo 1 of 1 : SP\_2019\_ST0001\_259\_38\_20190304\_00029.jpg

LM Start	7.94	Rating **	M	Issue No.	38
LM End	7.94	Issue Type +	En	Location *	LS
Category	Earthen Levee			GPS Latitude/Longitude	
				Start	End
Item	Encroachments			38.727277 °	38.727277 °
				-121.717618 °	-121.717618 °
DWR ID	DWR_ST0001_01_f_2018_38				
Comment Code					
EQ : Equipment					
Inspector Comment					
There are beehives at this location.

View of beehives at the landside toe. Fall 2018.

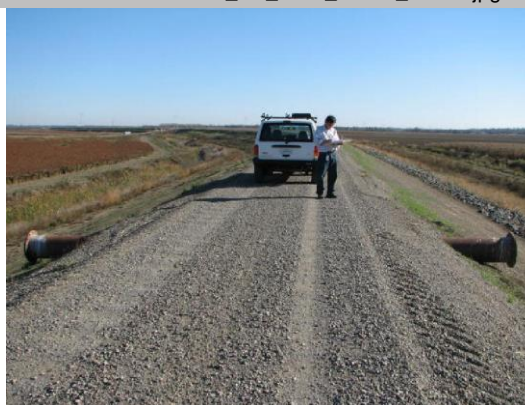
Photo 1 of 3 : UCIP\_SP\_2019\_53214\_60219.jpg

LM Start	10.40	Rating **	M	Issue No.	88
LM End	10.40	Issue Type +	En	Location *	
Category	Supplemental			GPS Latitude/Longitude	
				Start	End
Item	DWR UCIP Field Study			38.705051 °	38.705051 °
				-121.695577 °	-121.695577 °
DWR ID	17115				
Comment Code					
Inspector Comment					
FS_ID:53214 DS_ID:17115 EP_NO: N/A Repair Type: Non-Urgent Crossing Status: Found UCIP Comments: 10/19/16 w/s capped l/s capped FIELD_STRUCT_DESC: 18-inch, 0.25-inch-thick soil-proofed steel irrigation pipe through the levee, 4 feet below the crown. Pipe used for seasonal irrigation. Pipe opening capped on both ends. As-Built Drawing North Station 68+00. Pipe installed during Cache Creek Settling Basin Enlargement, 1991. FS Date: 11/16/2018 8:34:00 AM

Crown view: overview

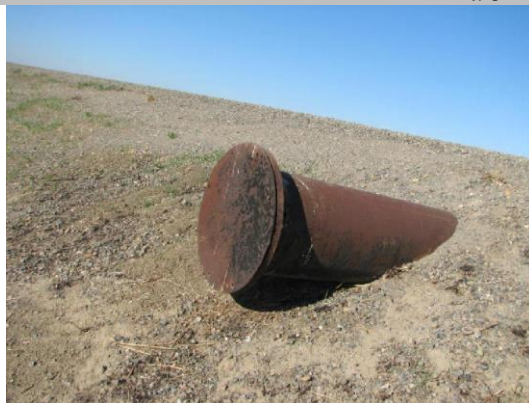
Photo 2 of 3 : UCIP\_SP\_2019\_53214\_60223.jpg

LM Start	10.40	Rating **	M	Issue No.	88 (cont)	
LM End	10.40	Issue Type +	En	Location *		
Category	Supplemental			GPS Latitude/Longitude		
				Start	End	
Item	DWR UCIP Field Study			38.705051 °	38.705051 °	
				-121.695577 °	-121.695577 °	
DWR ID	17115					
Comment Code						
Inspector Comment						
FS_ID:53214						
DS_ID:17115						
EP_NO: N/A						
Repair Type: Non-Urgent						
Crossing Status: Found						
UCIP Comments: 10/19/16 w/s capped l/s capped						
FIELD_STRUCT_DESC: 18-inch, 0.25-inch-thick soil-proofed steel						
irrigation pipe through the levee, 4 feet below the crown. Pipe used for						
seasonal irrigation. Pipe opening capped on both ends. As-Built						
Drawing North Station 68+00. Pipe installed during Cache Creek						
Settling Basin Enlargement, 1991.						
FS Date: 11/16/2018 8:34:00 AM

Waterside view: closer look at capped pipe.

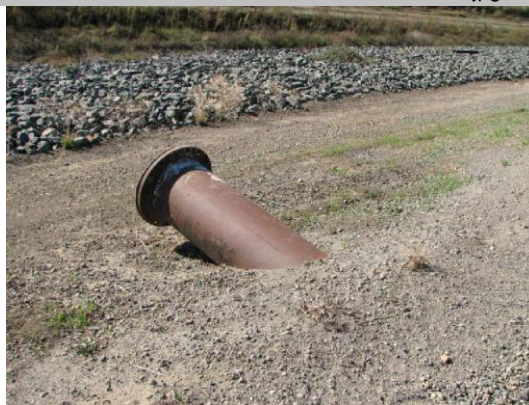
Photo 3 of 3 : UCIP\_SP\_2019\_53214\_60222.jpg

Waterside view: steel pipe on the slope of the levee

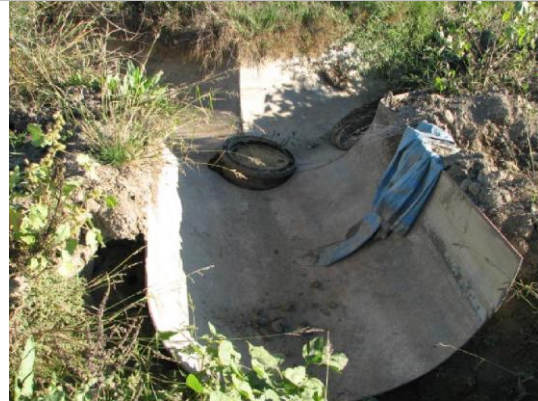
Photo 1 of 3 : UCIP\_SP\_2019\_53215\_60148.jpg

FS\_ID:53215  
DS\_ID:17119  
EP\_NO: N/A  
Repair Type: Non-Urgent  
Crossing Status: Found  
UCIP Comments: 11/3/2016: Per Ted Skidgel, new cap and gasket installed by farmer on LS vent, and siphon breaker/vent installed on WS. No permit was found for this work. Siphon breaker on WS needs cover. Repair Priority changed from No Action Needed to Non-Urgent. (K. Fazel - UCIP)08/16/2016: Repaired erosion L/S 8/16 pipe repaired by farmer prior to erosion. (T. Skidgel - ST0001). (Note: crossing was downgraded from Urgent to No Action Needed)06/28/2016: Erosion still present off LS shoulder, caused by leaking vent. Erosion to be repaired and backfilled this summer by Sac Yard. Pipe leaking at LS toe into ditch (not affecting levee prism) (K. Fazel - UCIP).2013-2016: Pipe leaks, severe erosion from levee shoulder to pipe daylight on landside levee slope, summer of 2013 repaired erosion, pipe needs repaired. (P. Amatya - DWR)

FIELD\_STRUCT\_DESC: 18-inch, 0.25-inch-thick soil-proofed steel irrigation pipe, 2 feet below the crown. Capped vent on the apex of the pipe off the landside (LS) shoulder. Booster pump located off the LS toe at the LS toe ditch. Another groundwater pump is located a further distance off the LS toe. Pumped groundwater is conveyed to the toe ditch and a booster pump pumps water through the levee and into a waterside (WS) ditch in the Cache Creek Settling Basin. Distribution box off the WS toe at the WS toe ditch. Could not locate a positive closure device. [Additional Reference(s): USACE As-Constructed Drawing North Station 49+50].  
FS Date: 11/16/2018 8:35:41 AM

Waterside view: pipe in the ditch

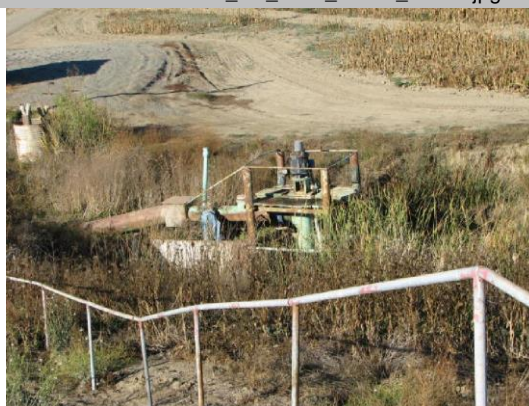
Photo 3 of 3 : UCIP\_SP\_2019\_53215\_60149.jpg

Comment Code						
Inspector Comment						
FS_ID:53215 DS_ID:17119 EP_NO: N/A Repair Type: Non-Urgent Crossing Status: Found UCIP Comments: 11/3/2016: Per Ted Skidgel, new cap and gasket installed by farmer on LS vent, and siphon breaker/vent installed on WS. No permit was found for this work. Siphon breaker on WS needs cover. Repair Priority changed from No Action Needed to Non-Urgent. (K. Fazel - UCIP)08/16/2016: Repaired erosion L/S 8/16 pipe repaired by farmer prior to erosion. (T. Skidgel - ST0001). (Note: crossing was downgraded from Urgent to No Action Needed)06/28/2016: Erosion still present off LS shoulder, caused by leaking vent. Erosion to be repaired and backfilled this summer by Sac Yard. Pipe leaking at LS toe into ditch (not affecting levee prism) (K. Fazel - UCIP).2013-2016: Pipe leaks, severe erosion from levee shoulder to pipe daylight on landside levee slope, summer of 2013 repaired erosion,pipe needs repaired. (P. Amatya - DWR) FIELD_STRUCT_DESC: 18-inch, 0.25-inch-thick soil-proofed steel irrigation pipe, 2 feet below the crown. Capped vent on the apex of the pipe off the landside (LS) shoulder. Booster pump located off the LS toe at the LS toe ditch. Another groundwater pump is located a further distance off the LS toe. Pumped groundwater is conveyed to the toe ditch and a booster pump pumps water through the levee and into a waterside (WS) ditch in the Cache Creek Settling Basin. Distribution box off the WS toe at the WS toe ditch. Could not locate a positive closure device. [Additional Reference(s): USACE As-Constructed Drawing North Station 49+50]. FS Date: 11/16/2018 8:35:41 AM

Landside view: pumping plant

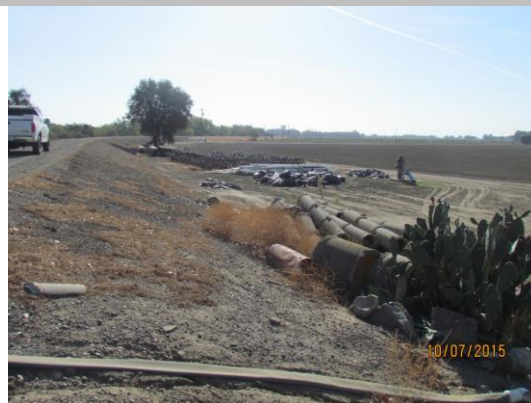
Photo 2 of 2 : SP\_2019\_ST0001\_260\_3\_20190304\_00003.jpg

LM Start	2.40	Rating **	M	Issue No.	3
LM End	2.43	Issue Type +	En	Location *	LS
Category	Earthen Levee			GPS Latitude/Longitude	
				Start	End
Item	Encroachments			38.726182 °	38.726067 °
				-121.774859 °	-121.774430 °
DWR ID	DWR_ST0001_02_s_2018_3				
Comment Code					
DE : Debris					
Inspector Comment					
Irrigation lines and broken concrete pipes are on the landside of the levee.

View of the concrete pile at the toe of the landward side of the levee  
looking downstream. Fall 2015.

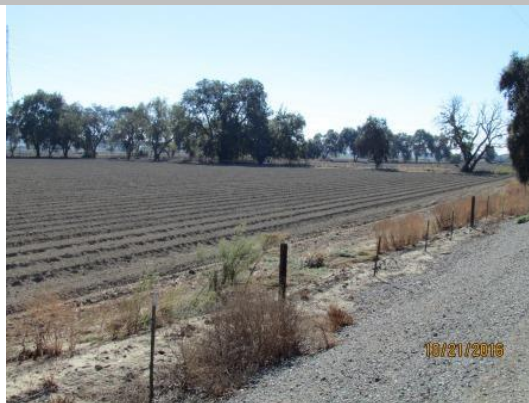
Photo 1 of 1 : SP\_2019\_ST0001\_260\_15\_20190304\_00016.jpg

LM Start	3.14	Rating **	M	Issue No.	15
LM End	3.52	Issue Type +	En	Location *	LS
Category	Earthen Levee			GPS Latitude/Longitude	
				Start	End
Item	Encroachments			38.720022 °	38.722053 °
				-121.763913 °	-121.759600 °
DWR ID	DWR_ST0001_02_f_2016_15				
Comment Code					
FE : Fence					
Inspector Comment					
There is a wire fence at the landside toe.

View of fence on LS slope. Fall 2016.

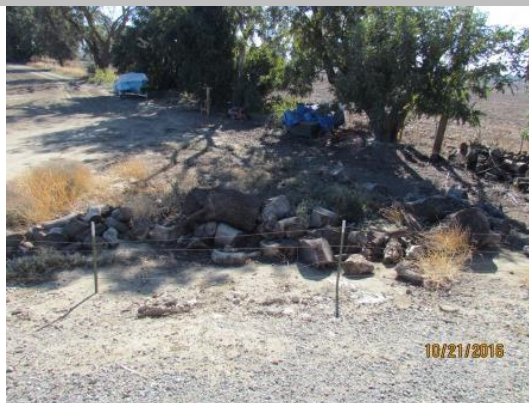
Photo 1 of 1 : SP\_2019\_ST0001\_260\_17\_20190304\_00018.jpg

LM Start	3.39	Rating **	M	Issue No.	17
LM End	3.39	Issue Type +	En	Location *	LS
Category	Earthen Levee			GPS Latitude/Longitude	
				Start	End
Item	Encroachments			38.720204 °	38.720204 °
				-121.759760 °	-121.759760 °
DWR ID	DWR_ST0001_02_f_2016_17				
Comment Code					
FW : Firewood					
Inspector Comment					
There is a firewood pile behind the wire fence.

View of firewood at LS levee toe. Fall 2016.

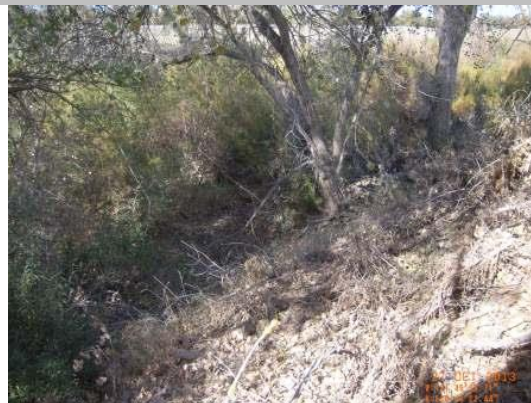
Photo 1 of 1 : SP\_2019\_ST0001\_260\_2\_20190304\_00001.jpg

LM Start	3.53	Rating **	A/W	Issue No.	2
LM End	3.60	Issue Type +	Ma	Location *	WS
Category	Supplemental			GPS Latitude/Longitude	
				Start	End
Item	2017 USACE Erosion Survey, DRAFT			38.722138 °	38.723294 °
				-121.759736 °	-121.759588 °
DWR ID	DWR_ST0001_02_f_2018_2				
Comment Code					
Inspector Comment					
2017 Site ID: CHC 3.5 R					
Status: Eroding					
2017 Field Notes: Significant amount of debris along bank.					
Site History: 2010 - Large slump on the upper berm, a tree has recently slid down the slope. 2011 - Large slump and new erosion. 2012 - Slightly steeper slopes and cracks observed.

USACE 2013 Photo #1

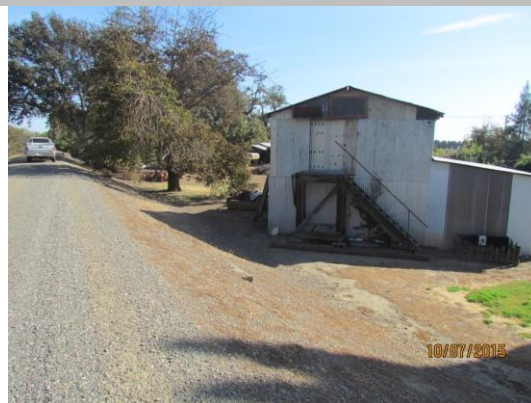
Photo 1 of 1 : SP\_2019\_ST0001\_260\_8\_20190304\_00008.jpg

LM Start	4.06	Rating **	M	Issue No.	8
LM End	4.06	Issue Type +	En	Location *	LS
Category	Earthen Levee			GPS Latitude/Longitude	
				Start	End
Item	Encroachments			38.723992 °	38.723992 °
				-121.752511 °	-121.752511 °
DWR ID	DWR_ST0001_02_s_2012_8				
Comment Code					
BU : Building					
Inspector Comment					
A building is within the easement of the levee.

View of the building on the landward side of the levee looking downstream. Fall 2015.

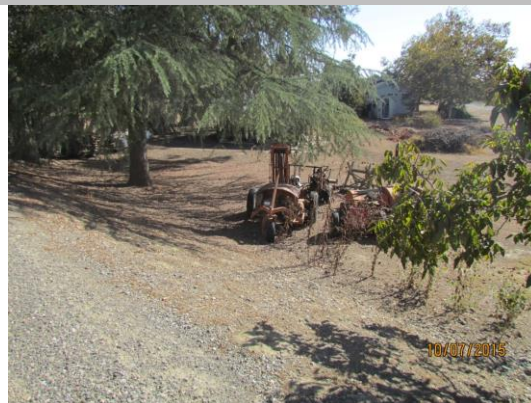
Photo 1 of 1 : SP\_2019\_ST0001\_260\_26\_20190304\_00020.jpg

LM Start	4.08	Rating **	M	Issue No.	26
LM End	4.08	Issue Type +	En	Location *	LS
Category	Earthen Levee			GPS Latitude/Longitude	
				Start	End
Item	Encroachments			38.724219 °	38.724219 °
				-121.752252 °	-121.752252 °
DWR ID	DWR_ST0001_02_f_2013_26				
Comment Code					
EQ : Equipment					
Inspector Comment

View of the equipment at the toe of the landward side of the levee. Fall 2015.

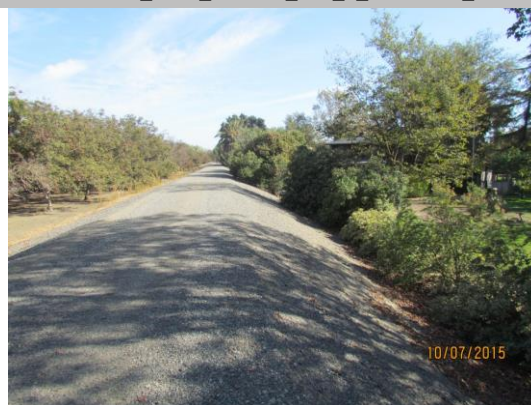
Photo 1 of 1 : SP\_2019\_ST0001\_260\_9\_20190304\_00009.jpg

LM Start	4.09	Rating **	M	Issue No.	9
LM End	4.18	Issue Type +	En	Location *	LS
Category	Earthen Levee			GPS Latitude/Longitude	
				Start	End
Item	Vegetation			38.724317 °	38.725242 °
				-121.752148 °	-121.751075 °
DWR ID	DWR_ST0001_02_s_2012_9				
Comment Code					
V6 : Landscaping					
Inspector Comment

View of the landscaping vegetation on the landward side of the levee looking downstream. Fall 2015.

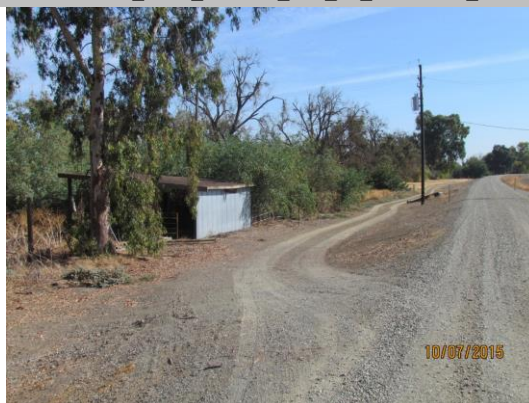
Photo 1 of 1 : SP\_2019\_ST0001\_260\_27\_20190304\_00021.jpg

LM Start	4.49	Rating **	M	Issue No.	27
LM End	4.49	Issue Type +	En	Location *	WS
Category	Earthen Levee			GPS Latitude/Longitude	
				Start	End
Item	Encroachments			38.727065 °	38.727065 °
				-121.746002 °	-121.746002 °
DWR ID	DWR_ST0001_02_f_2013_27				
Comment Code					
BU : Building					
Inspector Comment

View of the horse corral and building on the waterward side of the levee looking downstream. Fall 2015.

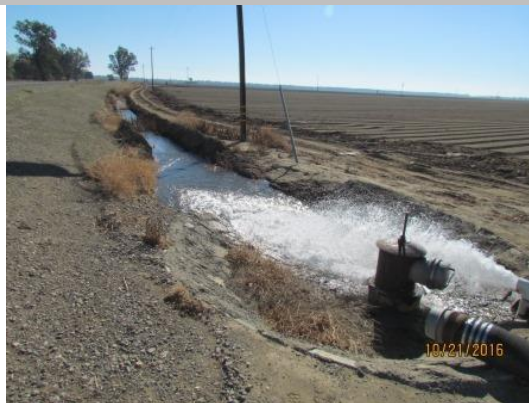
Photo 1 of 2 : SP\_2019\_ST0001\_260\_14\_20190304\_00014.jpg

LM Start	4.69	Rating **	M	Issue No.	14
LM End	4.80	Issue Type +	En	Location *	LS
Category	Earthen Levee			GPS Latitude/Longitude	
				Start	End
Item	Encroachments			38.727588 °	38.727158 °
				-121.742387 °	-121.740499 °
DWR ID	DWR_ST0001_02_s_2016_14				
Comment Code					
DT : Ditch					
Inspector Comment

View of ditch on landside near the levee toe looking downstream of Cache Creek. Fall 2016.

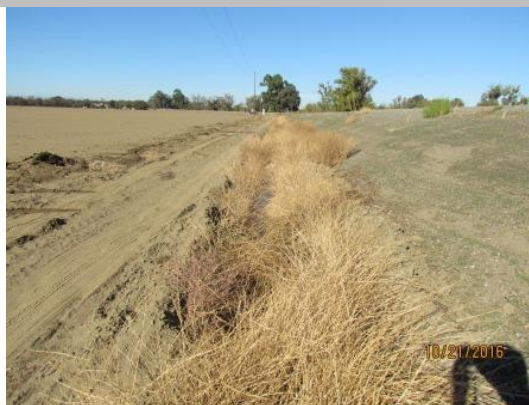
Photo 2 of 2 : SP\_2019\_ST0001\_260\_14\_20190304\_00015.jpg

View of ditch on landside near the levee toe looking upstream of Cache Creek. Fall 2016.

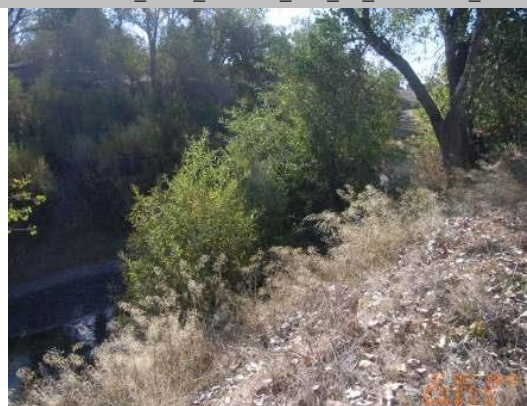
Photo 1 of 1 : SP\_2019\_ST0001\_260\_11\_20190304\_00011.jpg

LM Start	5.33	Rating **	A/W	Issue No.	11
LM End	5.37	Issue Type +	Ma	Location *	WS
Category	Supplemental			GPS Latitude/Longitude	
				Start	End
Item	2017 USACE Erosion Survey, DRAFT			38.722933 °	38.723467 °
				-121.760561 °	-121.760436 °
DWR ID	DWR_ST0001_02_f_2018_11				
Comment Code					
Inspector Comment					
2017 Site ID: CHC 5.4 L					
Status: Eroding					
2017 Field Notes: Site continues to erode due to recent high storm events.					
Site History: 2009 - Erosion into the levee slope. 2010 - Minor new erosion. 2011 - New erosion and a freshly fallen tree. 2012 - New animal holes and slightly steeper slopes. 2013 - New tree popout and 2 feet of erosion along the top bank.

USACE 2013 Photo #1

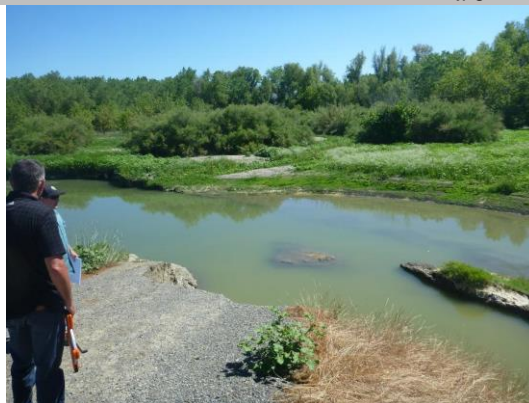
Photo 3 of 3 : LEVAL\_SP\_2019\_250\_973.jpg

LM Start	2.26	Rating **	M	Issue No.	1 (cont)	
LM End	2.26	Issue Type +	Ma	Location *		
Category	Supplemental			GPS Latitude/Longitude		
				Start	End	
Item	2017 Storm Damage			38.695424 °	38.695253 °	
				-121.715914 °	-121.715926 °	
DWR ID	DWR_ST0001_04_f_2017_1					
Comment Code						
Inspector Comment						
Levee Evaluation Comments						
Description:						
Site ID No:250						
Site Designation:LMA-58						
Repair Type: Erosion						
Rating:Area of Concern						
Field Date:6/2/2017						
Notes: training levee end slope where it keys into channel /access ramp erosion. No change as of fall 2018 inspection.
